Manhole Inspection Summary

Manhole # S21C__015MH

Location Address: **1711 EDMONDSON-ALLEY-FRANKLIN** Cross Street: **ALLEY-FULTON-MOUNT**

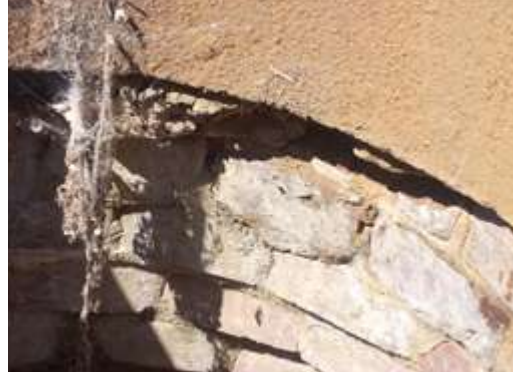
Defect 3

Condition: ☐ Sound ☐ Cracked ☐ Root Intrusion ☐ Loose Brick ☒ **Deteriorated**

DETERIORATION OF CHIMNEY

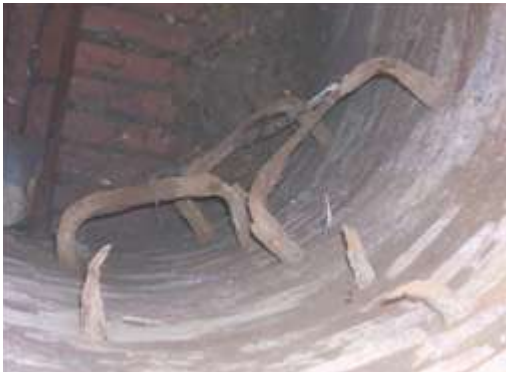
Defect 2

Steps Count: **3** Missing: **2** ☒ **Corroded**

CORRODED AND MISSING STEPS

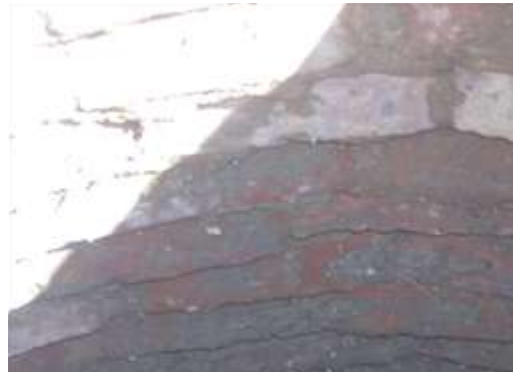
Defect 1

Infiltration: ☐ None ☐ Joint ☐ Cracks ☐ Mortar ☐ Roots ☒ **Wall**

CORBEL INFILTRATION

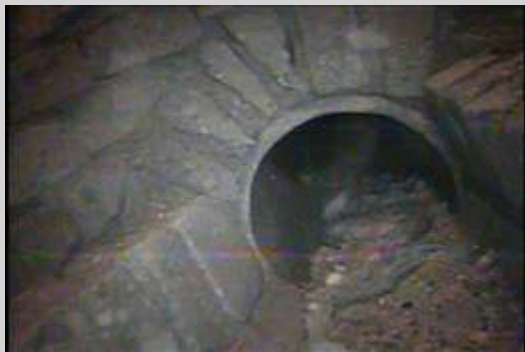
12 O'Clock Outflow

Pipe Height: **8.4** (in.) Rod and Bar (Angled)
Pipe Material: **Clay** ☐ Pipe Lined
Invert Depth: **9.29** (ft.) Flow Characteristics: **Slow**
Deposits: ☐ None ☐ Mud ☐ Sludge ☒ **Debris** ☐ Grease
Silt Depth: **3** (in.) Deposits Extent: **Medium**
Infiltration: **None** Pipe Seal Cond: **Sound**

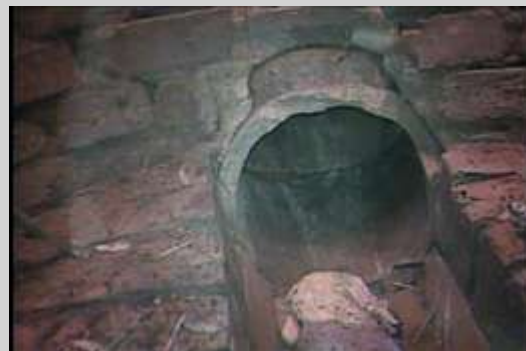
Drop In @ 3 O'Clock

DETERIORATION OF CHIMNEY

Drop: **Outside** Rod and Bar
Angled: **Yes** Reading: **7.30** (ft.)
Inv Depth: **8.30** (ft.)

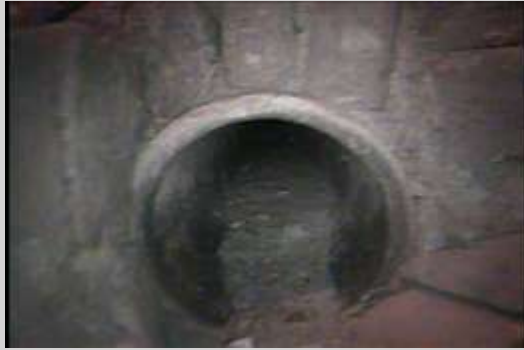
8 O'Clock Inflow

Deposits: ☐ None ☐ Mud ☐ Sludge ☒ **Debris** ☐ Grease

Silt Depth: **1** (in.) Deposits Extent: **Light**
